CWRP WEEKLY CONSTRUCTION PROGRESS REPORT

Week ending July 27, 2013

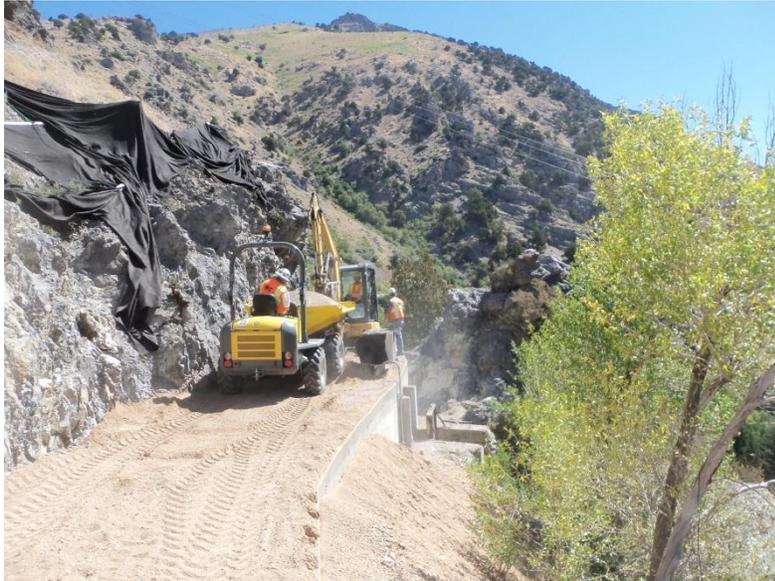
This week on the Canyon Segment, Whitaker began backfilling on the west side of the segment near the emergency bypass location heading east up the canyon. Crews used the large turn around area near the transition structure as a loading area and were able to supply backfill material to the front running mini excavator with two dump buggies. Crews continued to use the foam and retaining curb backfill cross section as the downhill slope in this area is very steep and in many places the slope is vertical. By the end of the week, crews had backfilled up to the western gabion basket location.

Backfilling box culvert near emergency bypass location

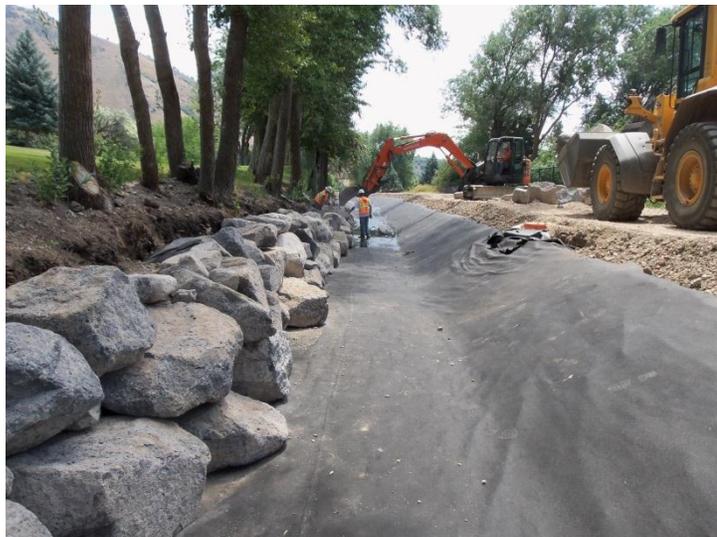
Rock wall placement at the Logan Golf and Country Club

Once the channel was lined, Whitaker went back through the alignment and began placing rock walls in selected sections to protect the existing trees and structures. Crews also began work on the placement of cobble rock after the rock walls were complete.

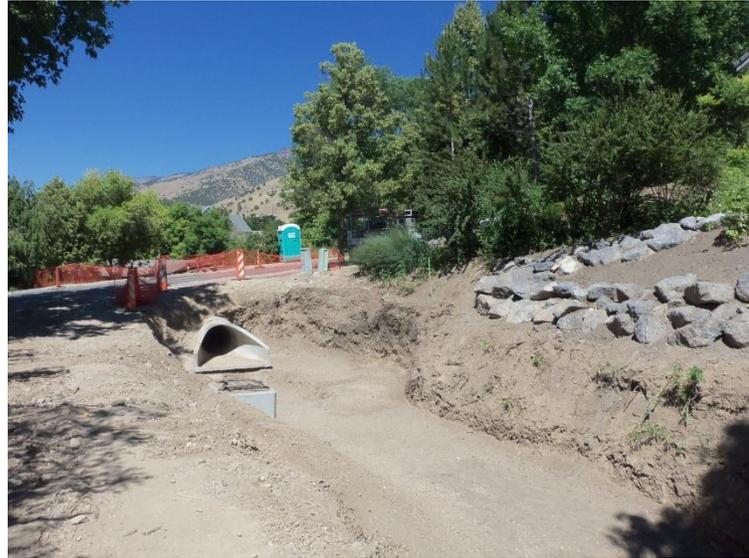
The 1220 N crew continued excavation of the landscaped channel between Cedar Heights Dr. and 1220 N. Crews coordinated with Logan City and the project team daily to determine the cross section of the channel in the narrow areas encountered in this location of the segment. The liner sub-contractor was also on this portion of the segment this week and was able to line a portion of the prepared channel.

Graded Channel ready for lining near 1220 N

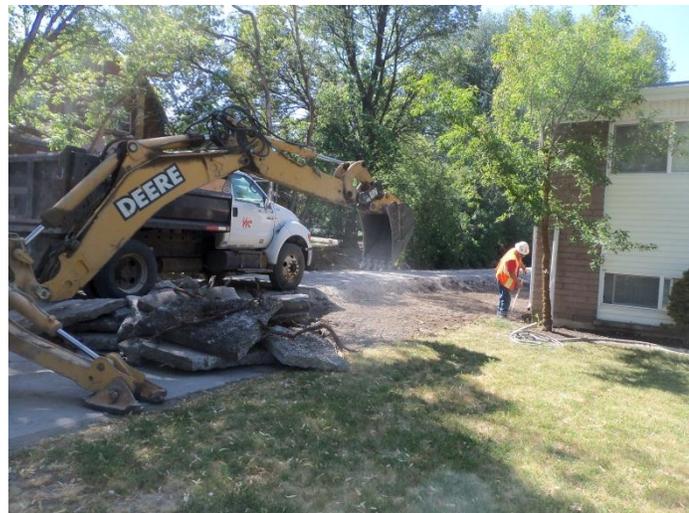
Very little activity occurred on this segment this week. Crews were able to perform prep work on an apartment complex drive way that was damaged during the pipe installation near 600 N and 600 E. Crews removed the old concrete, compacted the subgrade, and imported road base for the foundation of the new drive way.

Excavation of existing drive way at 600 N

Next week, crews will finish the subgrade and forming work and pour the new driveway for the apartment complex.
